Superfund Five-Year Review Report

Pickettville Road Landfill Jacksonville, Duval County, Florida

Prepared for
U.S. Environmental Protection Agency, Region IV
September 1999

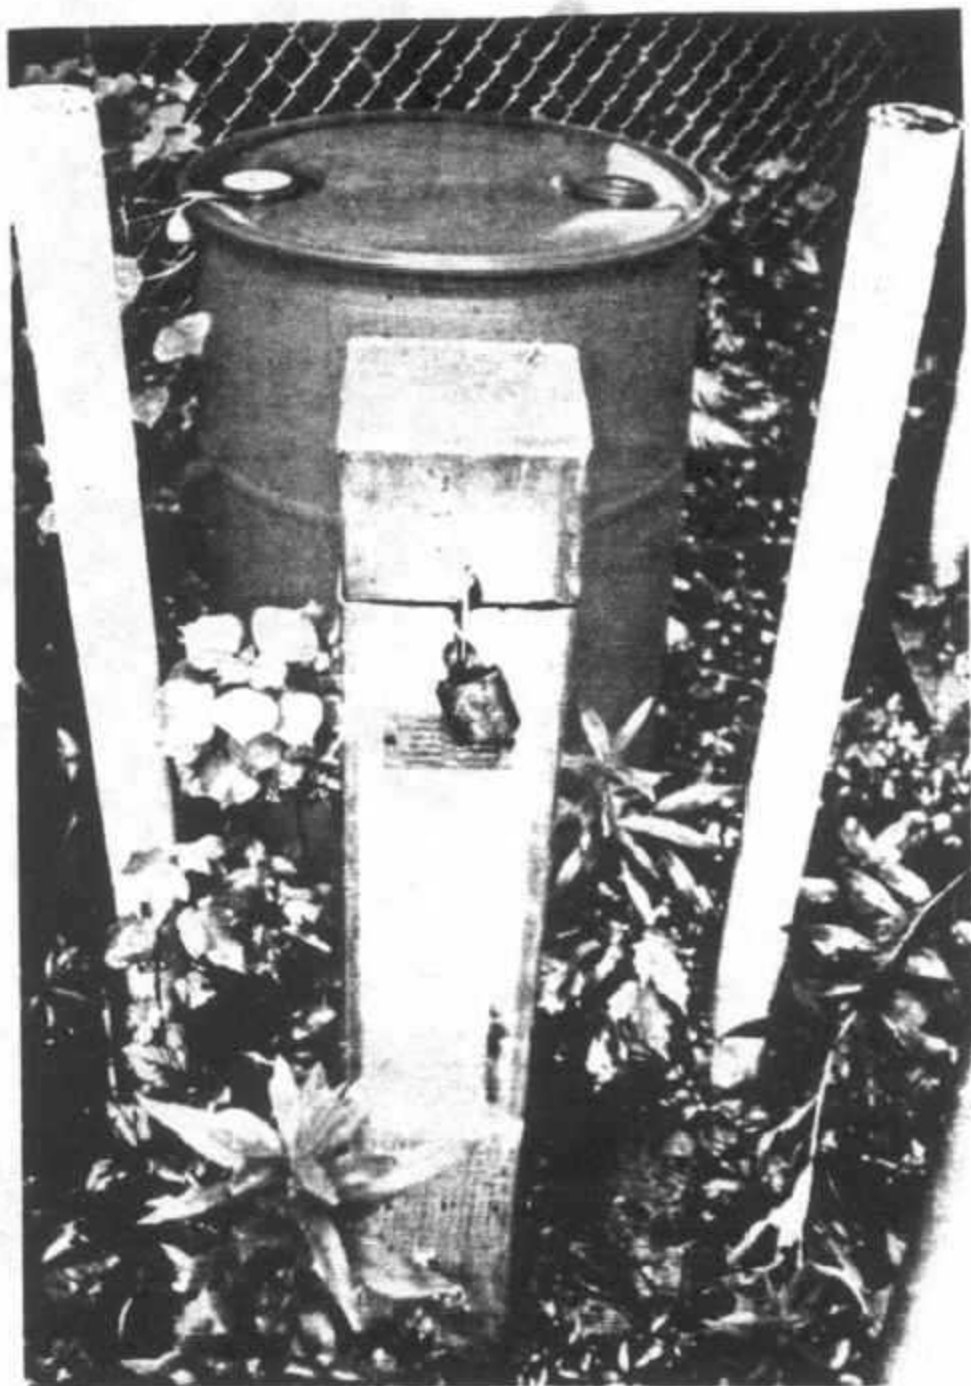
Photograph #11

Description: Typical gas monitoring probe and rain gauge. Gas monitoring probes are located on either side of the gas collection trench.
